Report on the investigation of  
a fatal man overboard from the Reflex 38 yacht  
***Lion***

14.5 miles south of Selsey Bill, West Sussex

18 June 2011

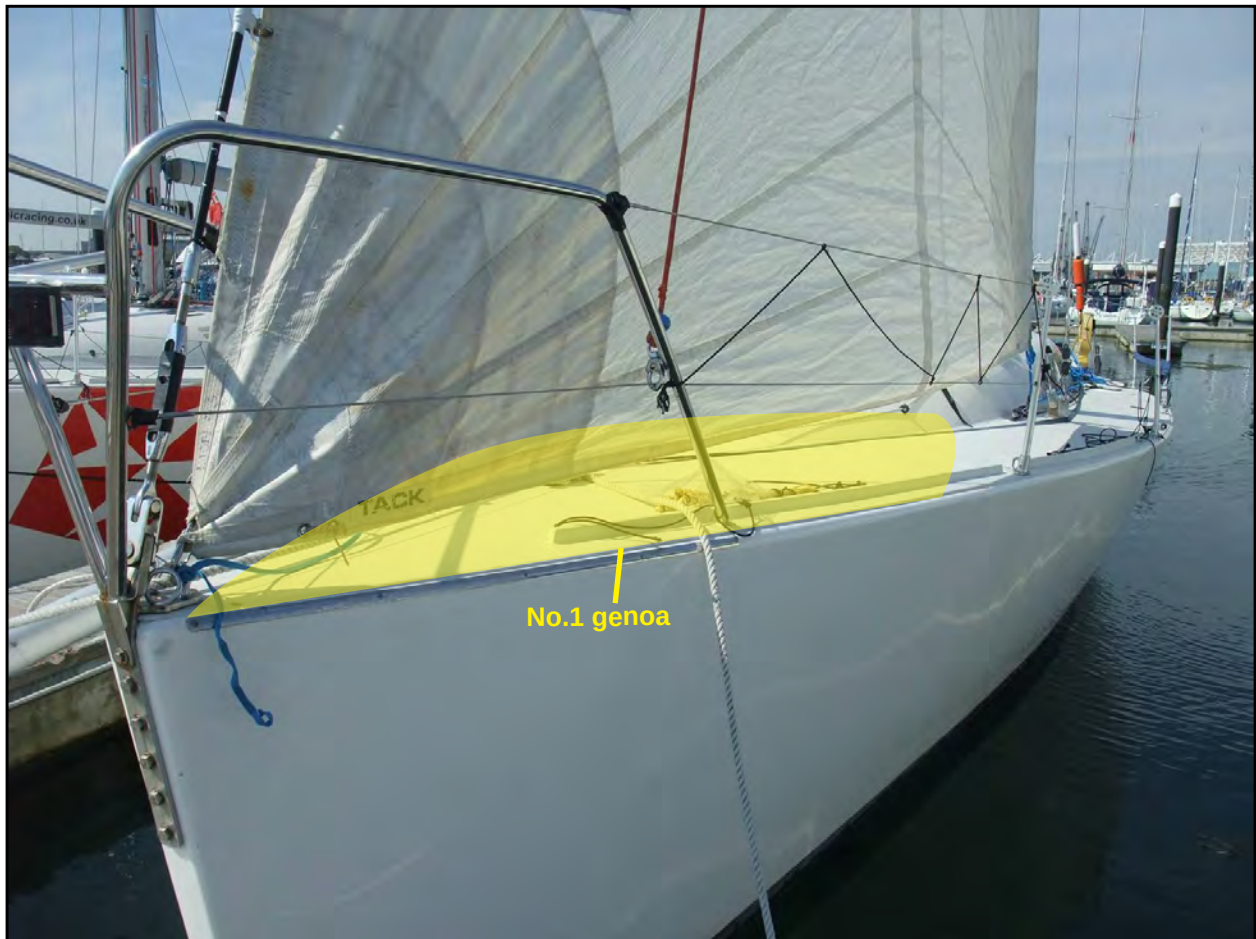
As the weather deteriorated, trimmer 2 noticed that the No.1 genoa was slipping from its lashings. He clipped his tether to the starboard jackline, went forward up the starboard side and used two additional sail ties to re-secure it.

At 0027, the helmsman felt the yacht's handling characteristics change. At the same time, he noticed that the No.1 genoa had slipped from its lashings and was streaming down the port side of the yacht. However, the tack remained secured to the forward pad eye, which prevented the sail from floating away. The skipper called the bow and mast men to the deck to help recover the sail if required. Meanwhile the helmsman concentrated on maintaining a steady course to assist the recovery operation. As the mast man entered the cockpit he noted the wind speed indicator was reading 38 knots. The yacht was heeling to port with her toerail dipping into the water.

**Figure 3:** Position of the lashed No.1 genoa

Following a sail change, it is good practice to immediately stow the replaced sail below deck unless it is likely to be required again very soon after the change. Given that the wind strength when the sails were changed was above 30 knots, it was most unlikely that the No.1 genoa would have been used again during the race.

Stowing sails that are not in use below deck keeps the working deck free of clutter and eliminates the risk of high value sails being lost overboard. It also reduces the need for crew members to spend time in the forward, high-risk area during hostile weather and rough sea conditions. However, the skipper may have perceived that it was safer to have secured the No.1 genoa on deck in the prevailing circumstances, given that *Lion* was about to round Owers light buoy and sail upwind. This would have increased pitching and angle of heel.

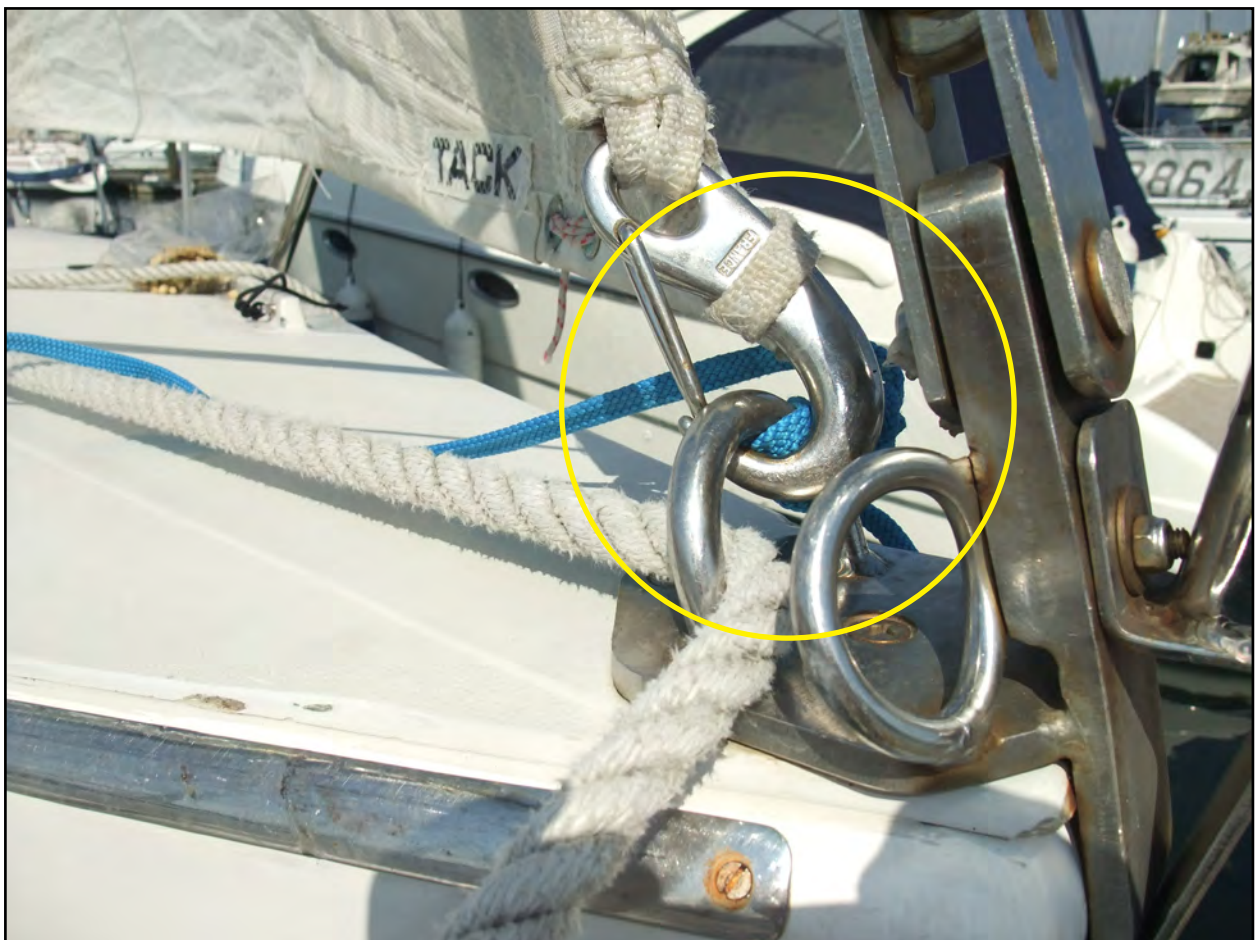
**Figure 4:** Genoa tack connected to the forward pad eye

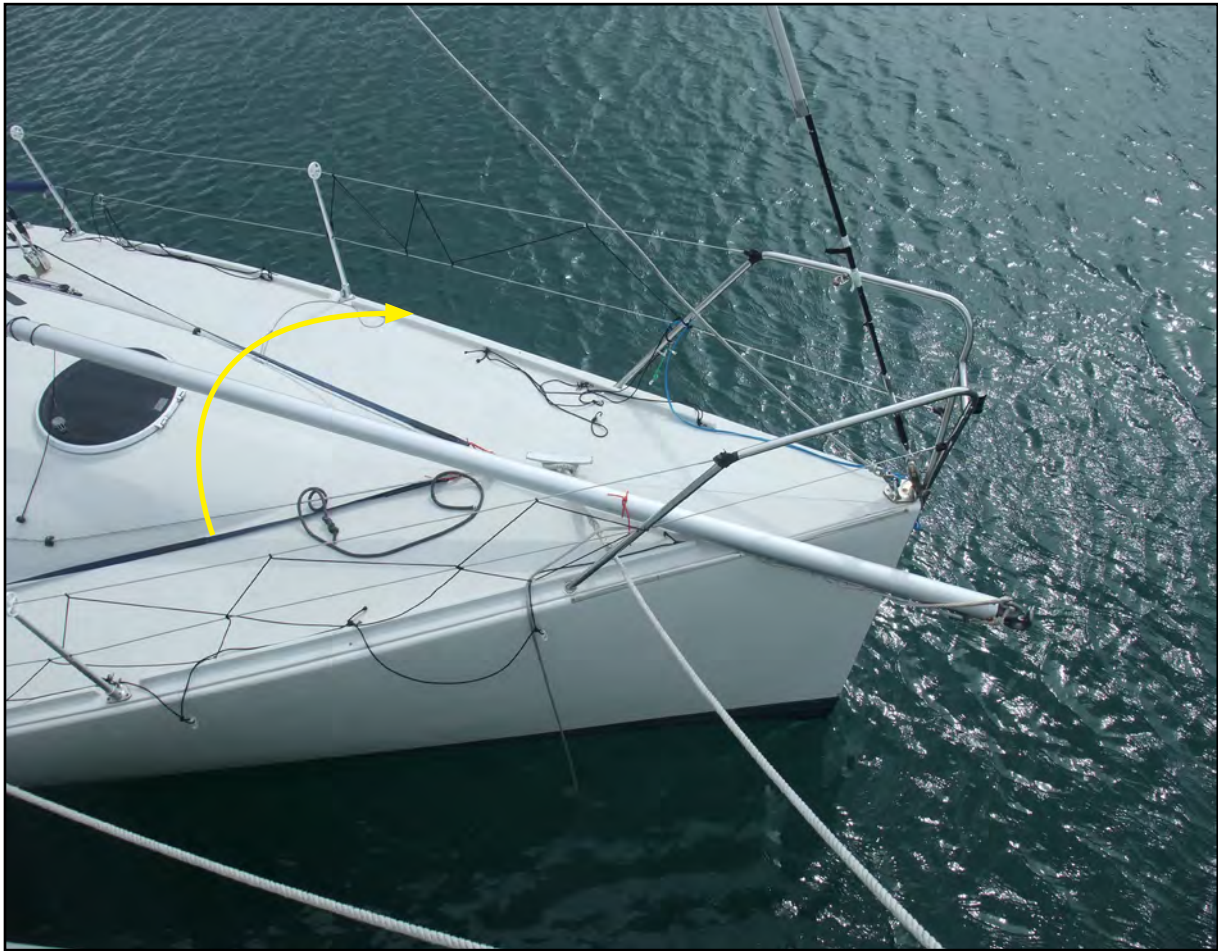
**Figure 7:** Approximate path believed to have been taken by the skipper when falling overboard

There is no doubt that the skipper went overboard on the port side. However, none of the crew could recall if his tether from the starboard jackline had passed over or under the spinnaker pole. A person, under momentum, could have passed through the 290mm gap under the pole, which could have also lifted as it was hinged to the mast. However, members of the recovery team do recall leaning over the spinnaker pole to pull on the skipper's tether. Had the tether passed under the pole, the weight of the skipper would have forced the tether to the deck and the crew would have suffered damage to their hands as they tried to gain grip on the tether with it pressed against the deck. In addition, had the skipper passed under the pole, it would have lifted as he was hauled inboard by the spinnaker halyard, which was connected to his tether. There is no evidence of this.

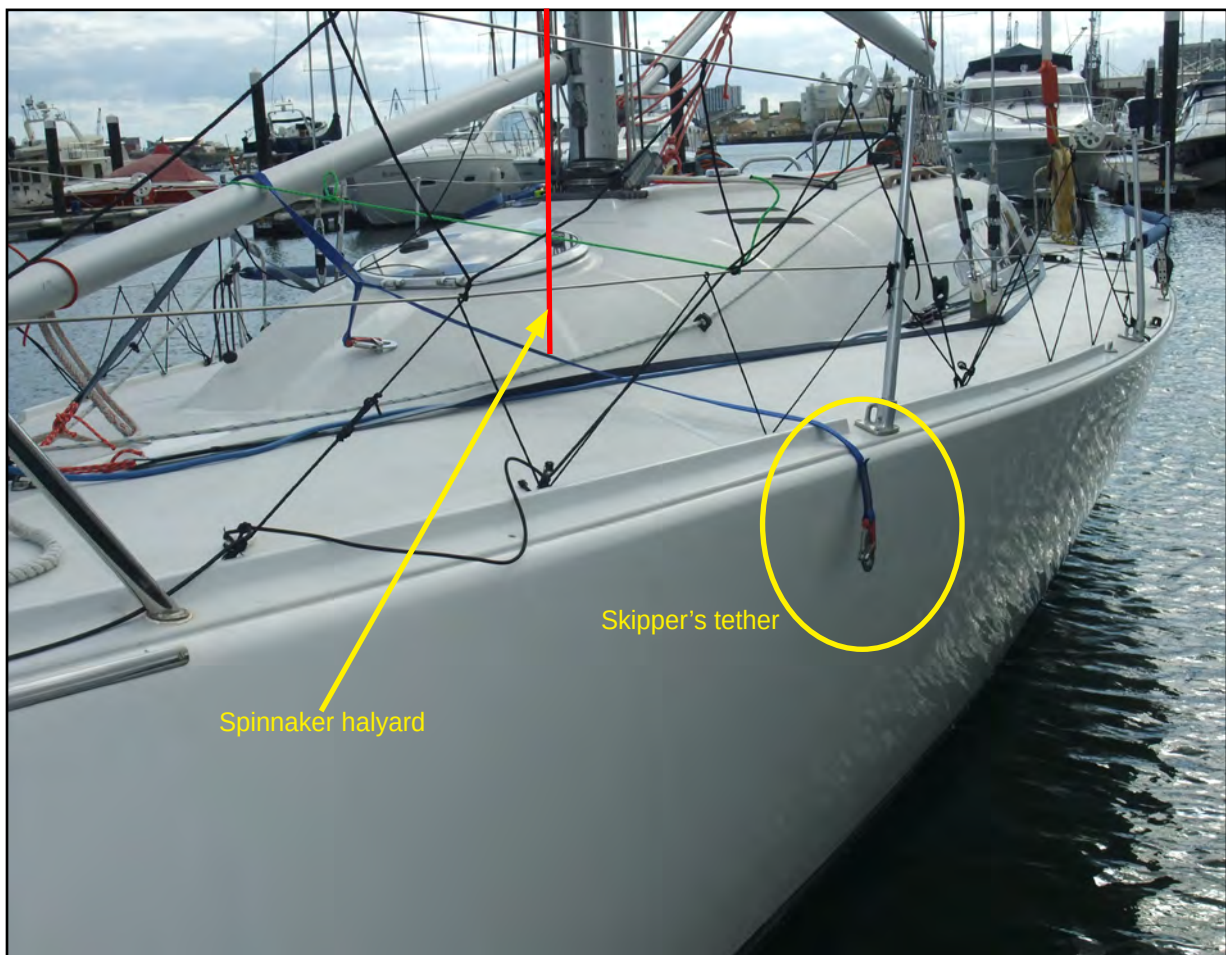
The skipper was found in the water on the port side with his lifejacket inflated and the lifejacket bladder over his head, obscuring part of his face. His tether was still connected to the starboard jackline and had passed over the spinnaker pole and under the lower guard wire between the pulpit and the first vertical stanchion (**Figure 7**). The mast and bow men went to the port side and attempted to pull the skipper out of the water. Trimmers 1 and 2 remained on the starboard side; they leant across the spinnaker pole and hauled on the skipper's tether. The team managed to raise the skipper's head above water, but there was no reaction from him. Attempts by the mast man to clear the skipper's airways and check for signs of life proved very difficult because of the obstructing lifejacket bladder.

**Figure 8:** Pictorial interpretation of the spinnaker halyard connected to the skipper's tether

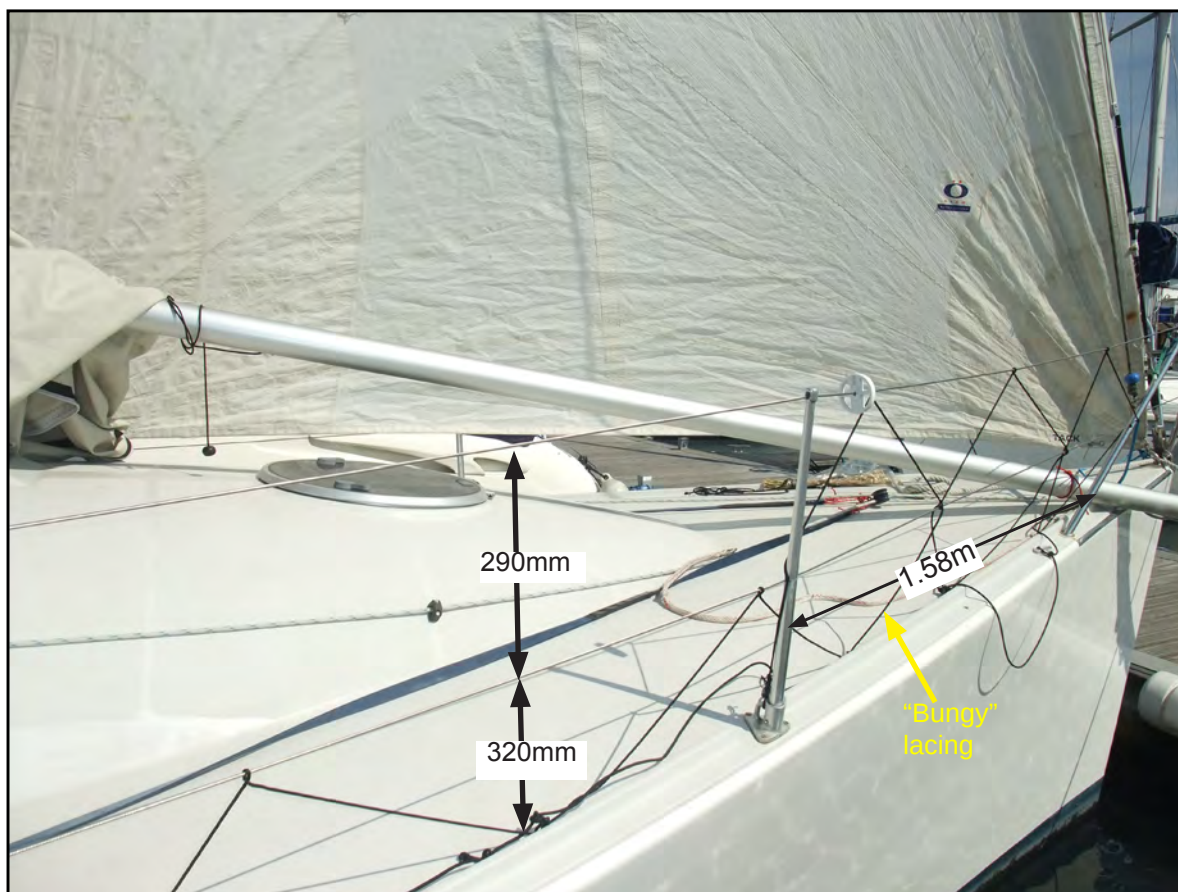
*Lion's* stainless steel vertical guard wire stanchions were 635mm high and equi-spaced at 2.14m intervals. The spacing between the lower end of the angled pulpit stanchion to the first vertical guard wire stanchion was 1.58m. Two stainless steel guard wires were fitted. The spacing from the deck to the lower guard wire was 320mm<sup>4</sup>, and from the lower to the upper guard wire, was 290mm.

A criss-cross combination of light “bungy” line and braided cordage lacing was used to help prevent sails from falling overboard. The lacing was fitted on each side from the deck to the upper guard wire between the pulpit after stanchion and the first vertical guard wire stanchion, and from the deck to the lower guard wire between the first and second vertical guard wire stanchions.

**Figure 10:** Stanchion, guard wire and lacing arrangements

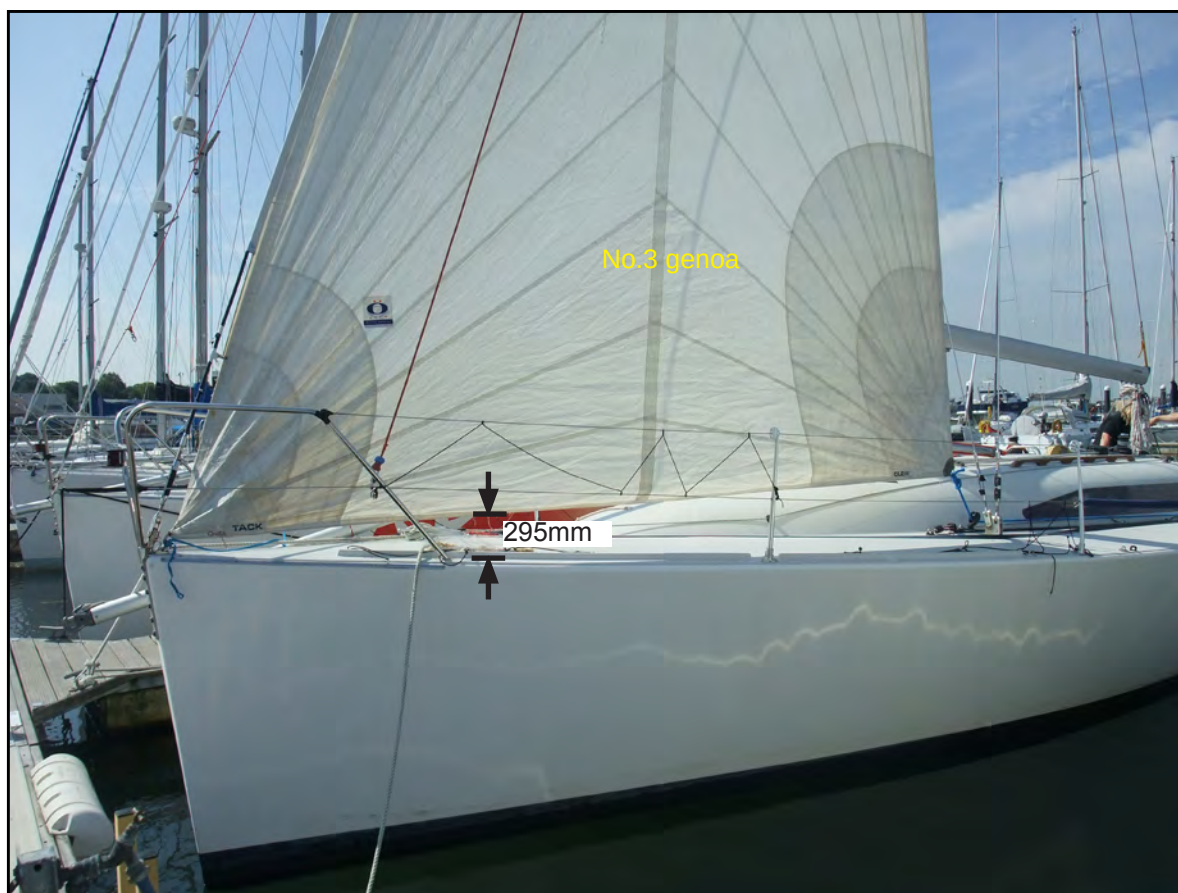
**Figure 11:** Gap between the foot of No.3 genoa and the deck

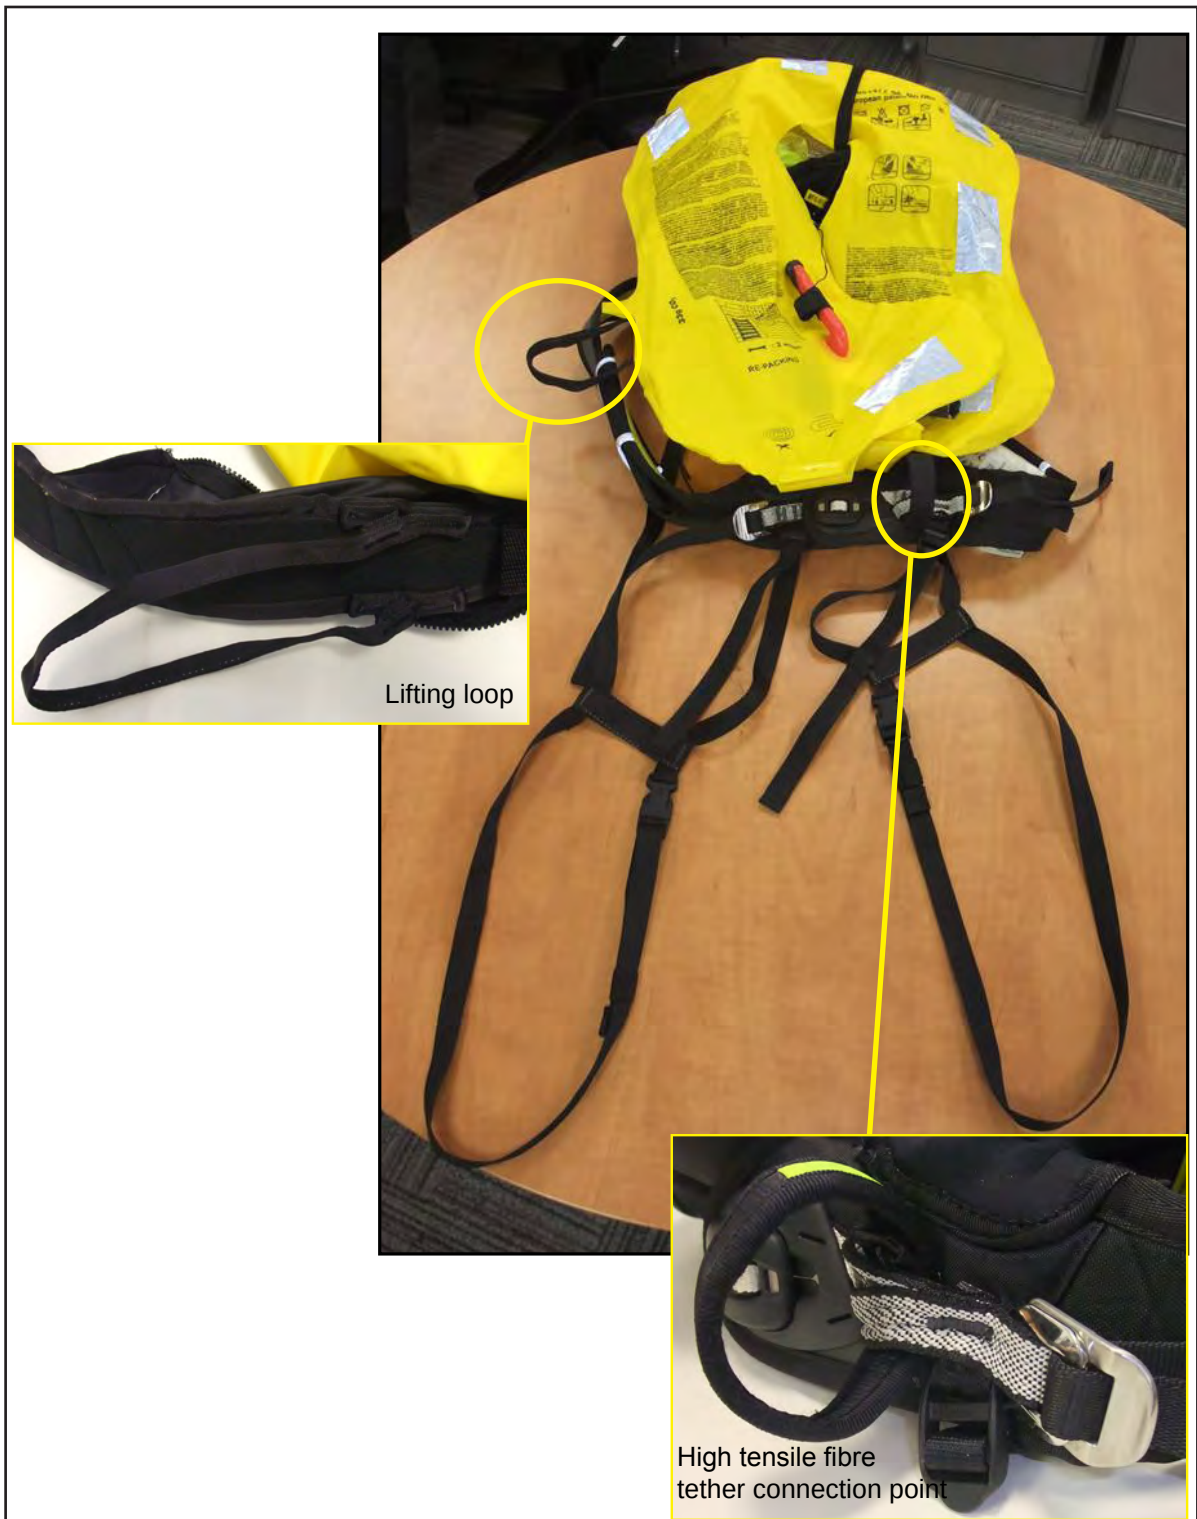
On inspection following the accident, the lifejacket, harness and thigh straps were found to be in good condition with no obvious damage to their components. The arrangement is shown at **Figures 12** and **13**.

**Figure 12:** Skipper's Spinlock Deckvest 150 Pro Sensor lifejacket, harness and thigh straps

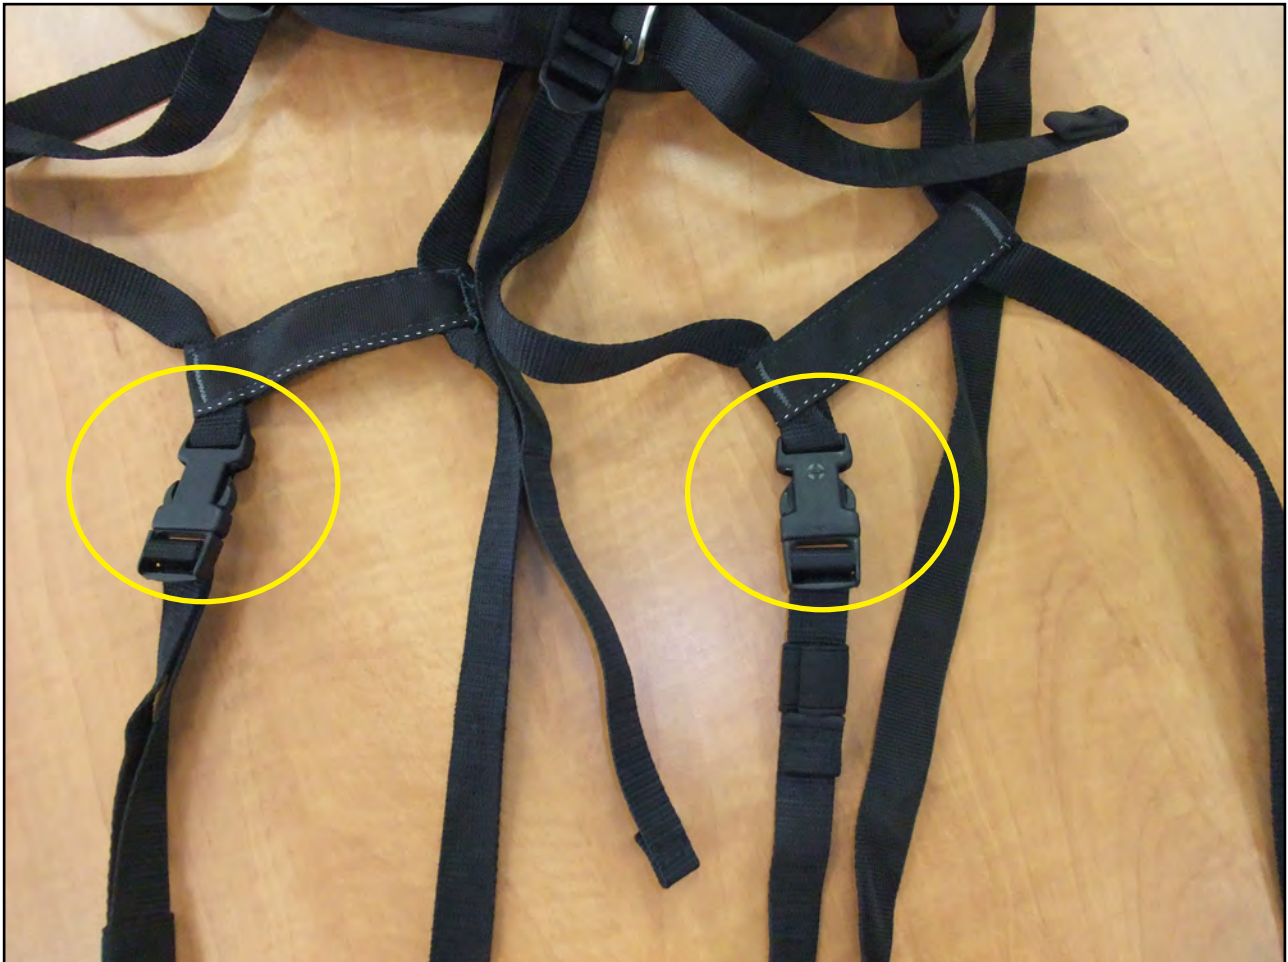
Following the accident it was noted that the thigh strap side release buckles were easily unclipped under straight load tension, and especially so under rotational load. Straight pull load tests showed that the left and right thigh strap buckles released when a load of 20 kilogram-force (kgf) and 40kgf was applied respectively. It is understood from the lifejacket manufacturer that the buckles should withstand a 50kgf load before unfastening.

**Figure 13:** Spinlock Deckvest 150 Pro Sensor lifejacket thigh strap side release buckles

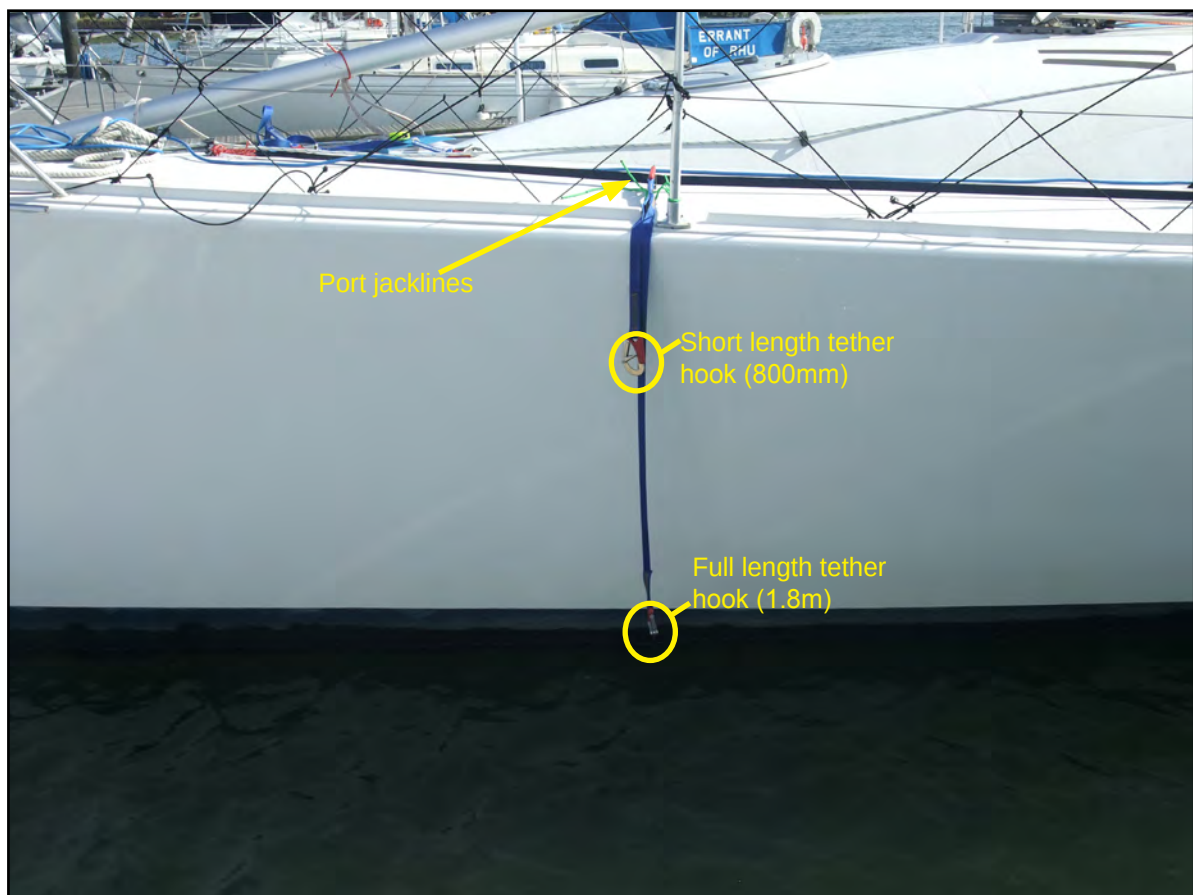
When a three-hook tether was connected to the deflected port jackline, the long and short tethers extended 1.2m and 500mm over the port deck edge respectively (**Figure 16**).

**Figure 16:** Three-hook tether connected to the port jackline

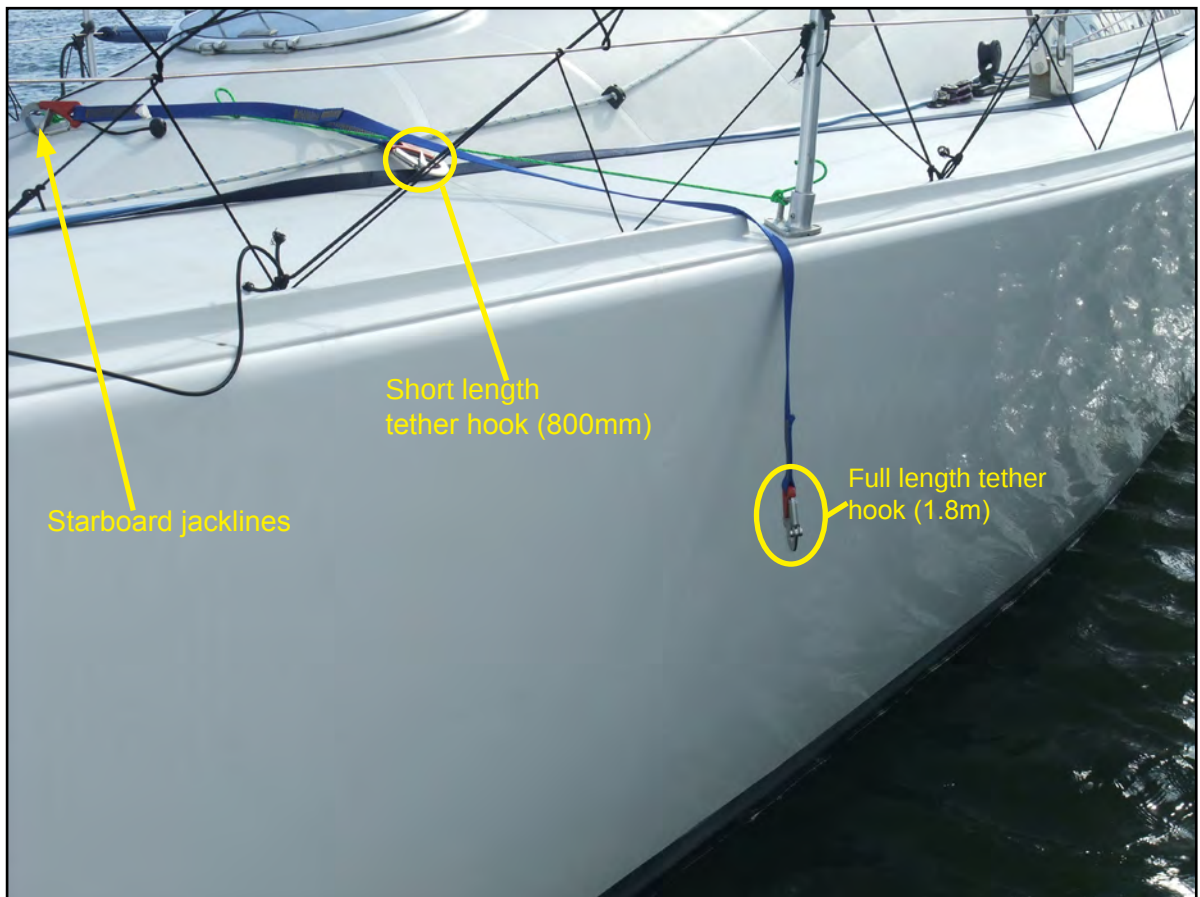
When the same three-hook tether was connected to the starboard jackline and passed under the spinnaker pole, the long tether extended 450mm over the port deck edge. When passed over the spinnaker pole it extended 250mm over the port deck edge (**Figure 17** and **18**). In both cases the short tether hook remained well clear of the port deck edge.

**Figure 17:** Three-hook tether connected to the starboard jackline and passing under the spinnaker pole

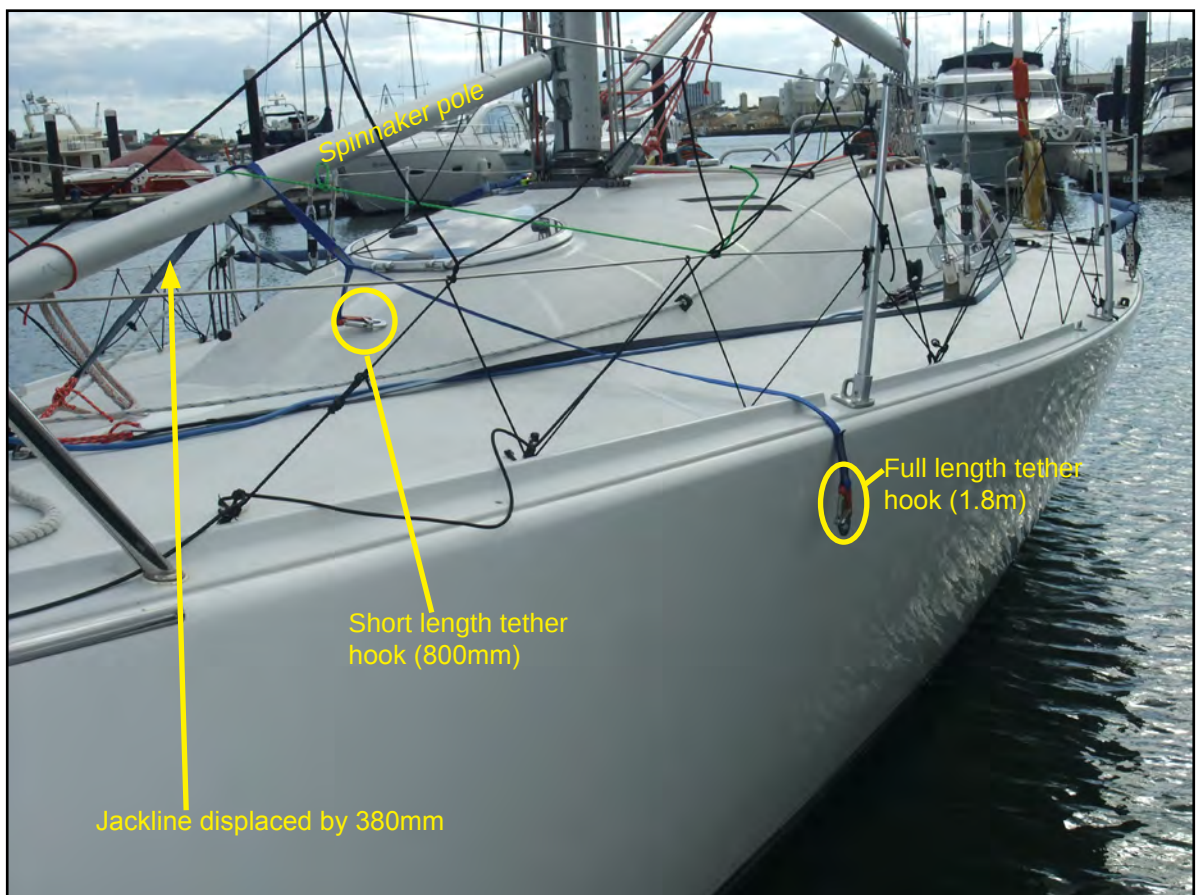
**Figure 18:** Three-hook tether connected to the starboard jackline and passing over the spinnaker pole
