Report on the investigation of  
a fatal man overboard from the Reflex 38 yacht  
***Lion***

14.5 miles south of Selsey Bill, West Sussex

18 June 2011

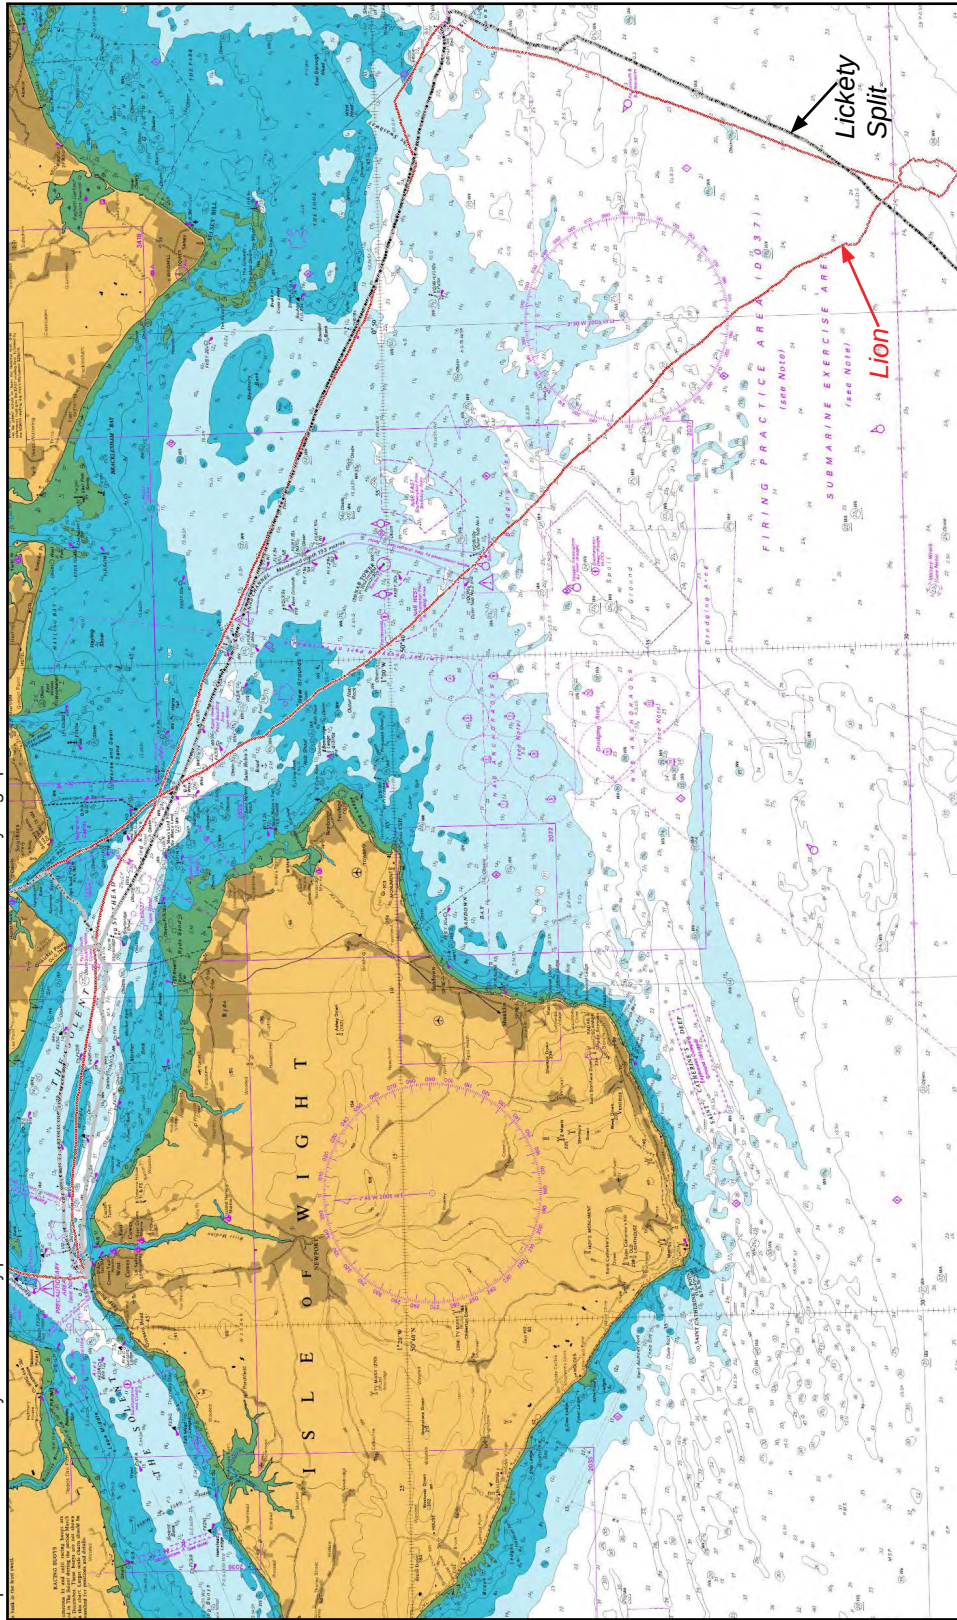
Figure 2: Chartlet showing AIS/GPS tracks for **Lion** and Lickety Split

The early stages of *Lion*'s race were uneventful as the yacht progressed east along The Solent close-hauled at speeds over the ground (SOG) of between 6.4 and 8 knots (**Figure 2**). At about 2025, the helmsman felt that with the No.3 genoa the boat was under-powered. The skipper agreed, and the sail was replaced with the No.2 genoa; the No.3 genoa was then taken into the cabin for repairs to the luff.

*Lion*'s combined Automatic Identification System (AIS) and GPS tracks up to the accident and the return leg to Portsmouth are at **Figure 2**. The figure also shows the AIS track for *Lickety Split*.

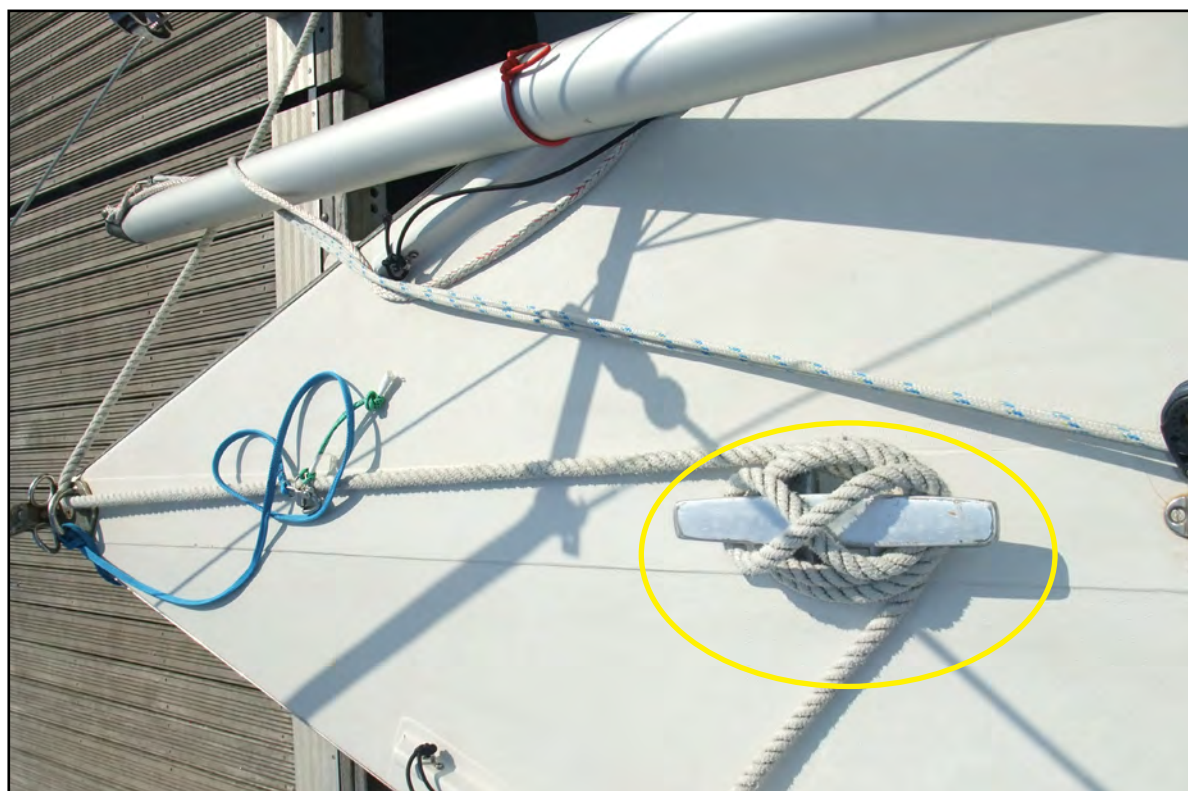
**Figure 5:** Position of the forward centreline cleat

As the skipper recovered the sail from the water it was passed along the starboard side by trimmers 1 and 2, and the navigator guided it down the companionway and into the cabin. When all of the sail was recovered on board, the skipper disconnected the tack from the forward pad eye. He then transferred his tether from the port to the starboard jackline in preparation to return to the cockpit along the high, starboard side, as was his usual practice. Almost immediately, the sail snagged and the skipper called “stop”. Trimmer 1 then saw him lie on the deck, on his stomach, facing forward and to starboard of the centreline. It is likely that the sail had snagged on the forward centreline cleat (**Figure 5**) and the skipper was attempting to free it. After a short time, the skipper called “OK” and the sail continued to be passed along the starboard side, partly over the coach roof and down the companionway into the cabin.

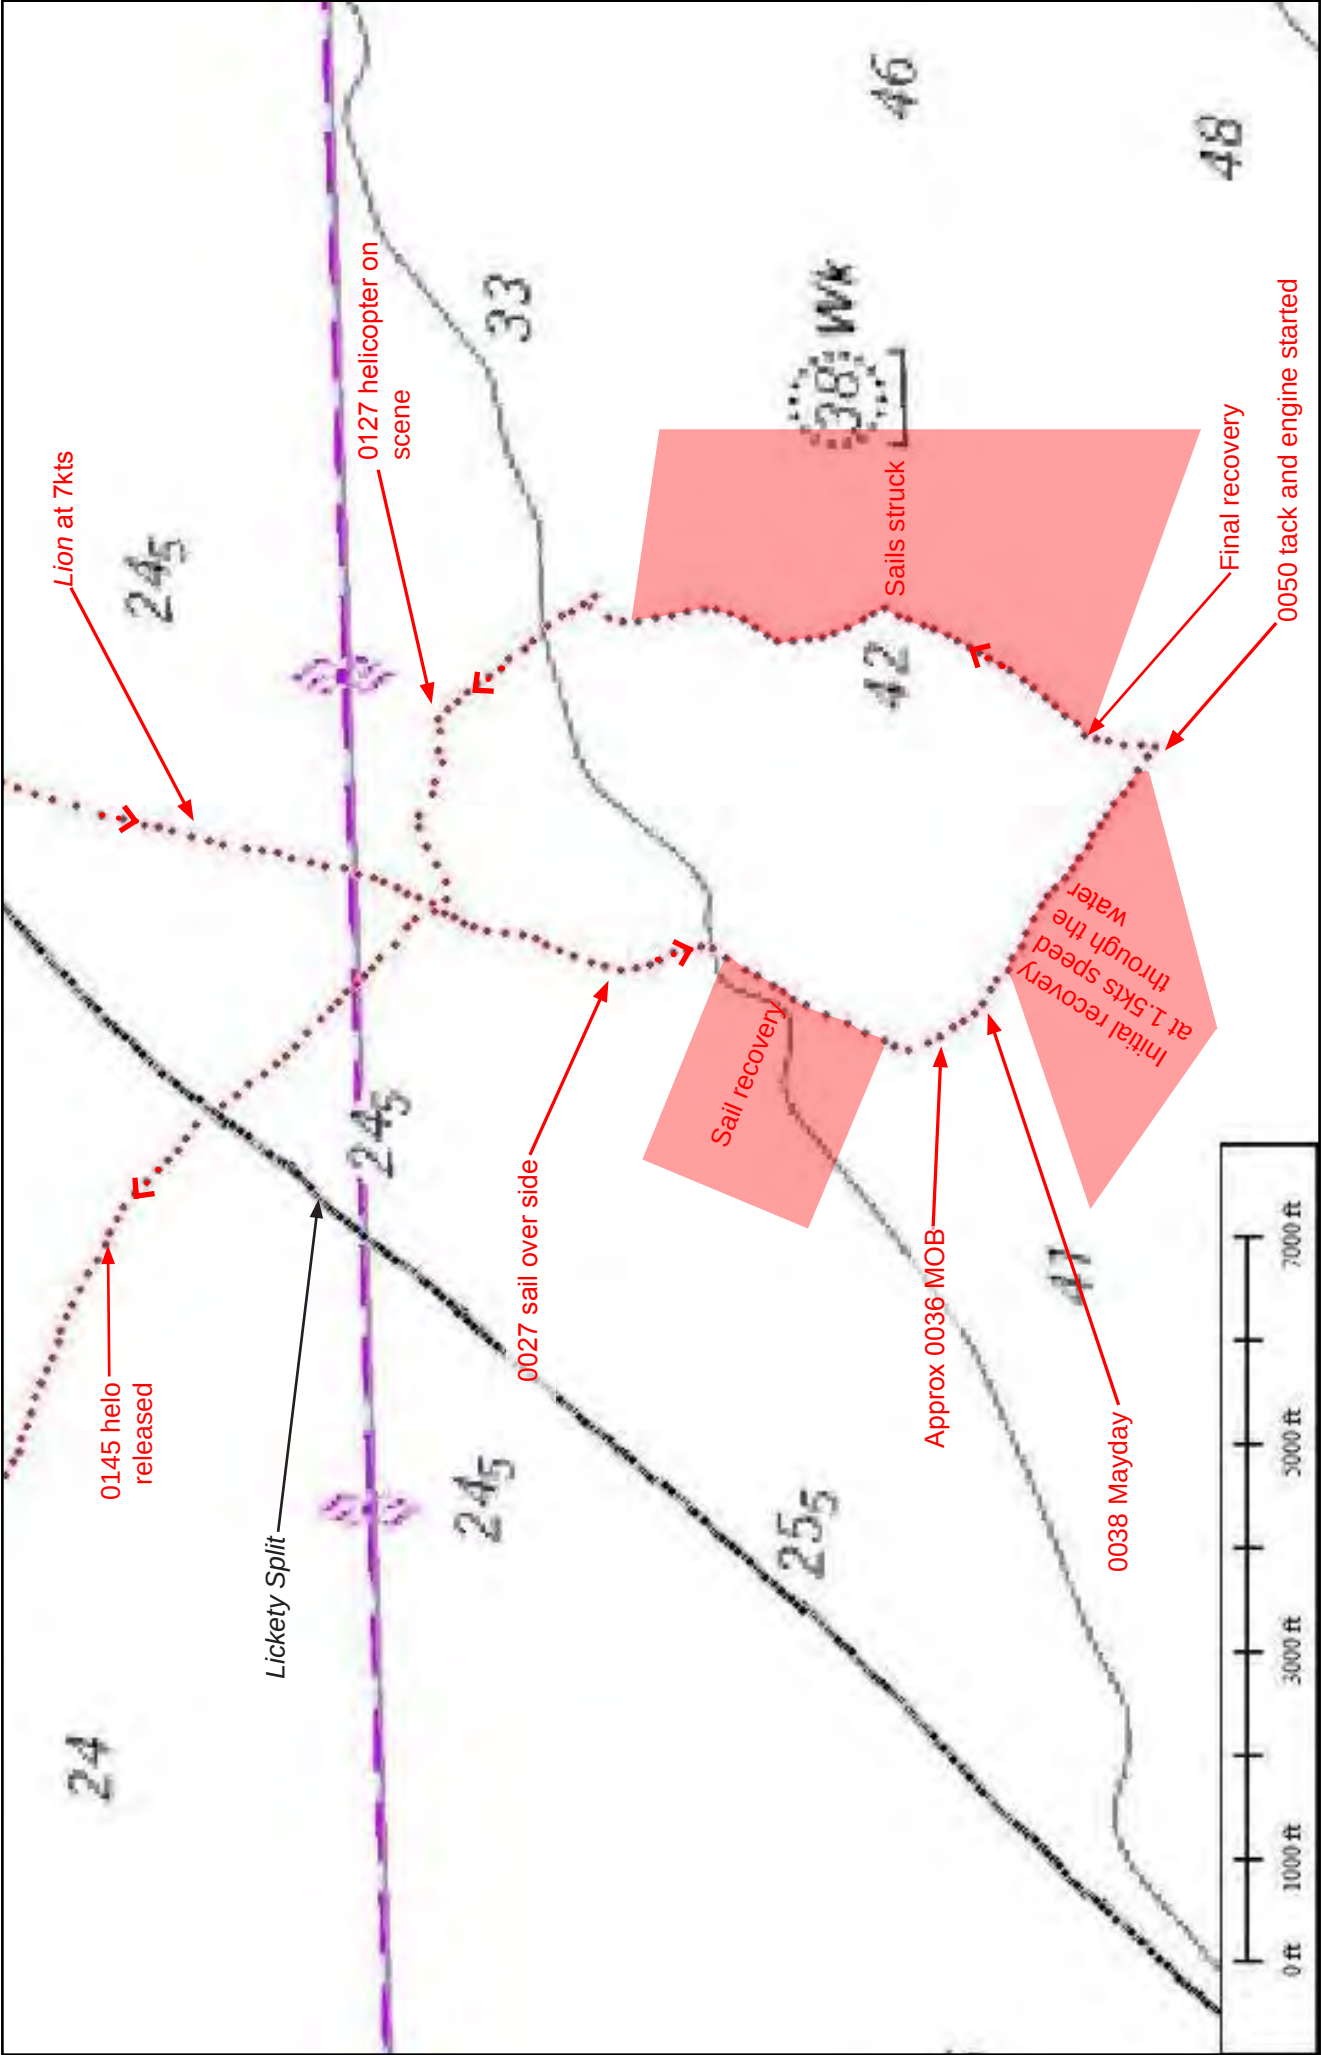
Figure 6: Detailed AIS track showing key events

To assist in the recovery, the helmsman instructed the general duties man to release the mainsheet, which had the effect of immediately slowing *Lion* down from 4.5 knots to 1.5 knots through the water, with a course over ground (COG) of approximately 135° True (T) (**Figure 6**).

A more detailed AIS track for *Lion*, showing the specific stages of the accident and actions taken, is at **Figure 6**.

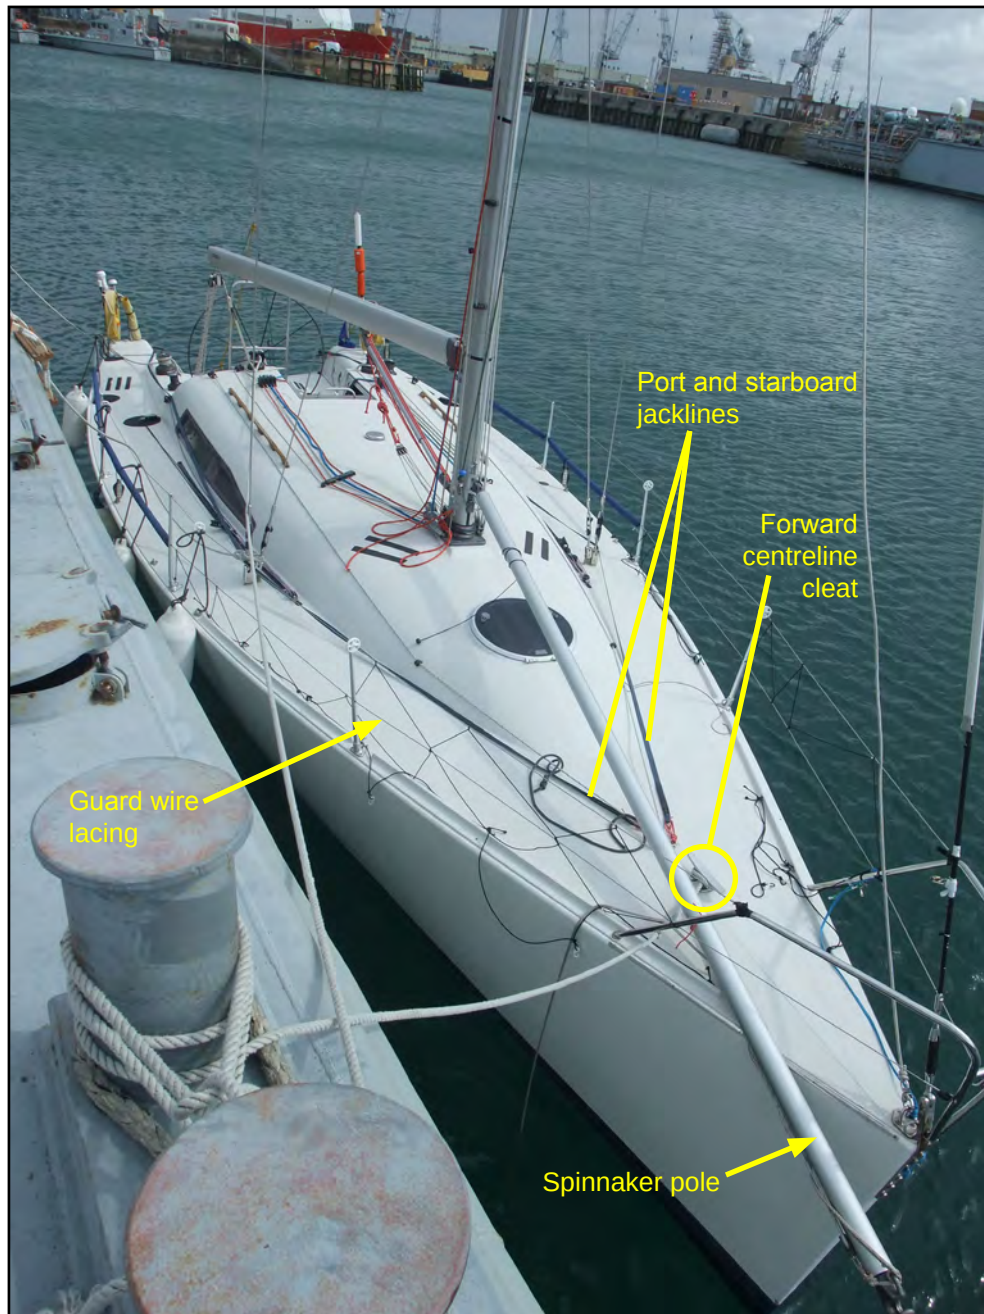
**Figure 9: Deck layout**

The port and starboard webbing jacklines were individually secured to the transom aft and to a forward common deck fitting positioned just aft of the cleat on the foredeck. On inspection, following the accident, the jacklines and fastenings were found to be in good condition.
